VISUAL TIMBER PEST REPORT

121 Smith St
RICHMOND

Report Prepared: 9 April 2015

Visual Timber Pest Inspection & Report

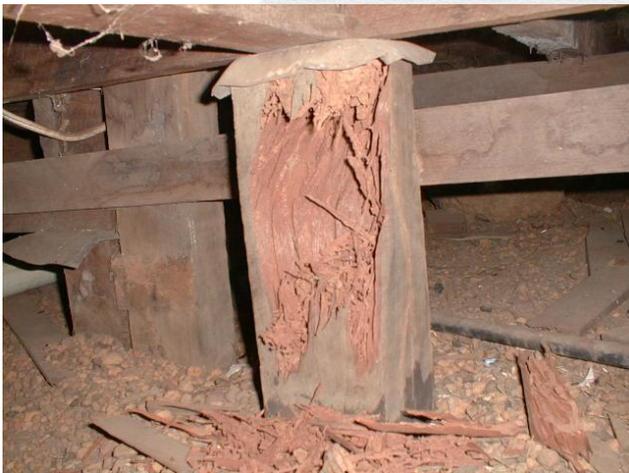
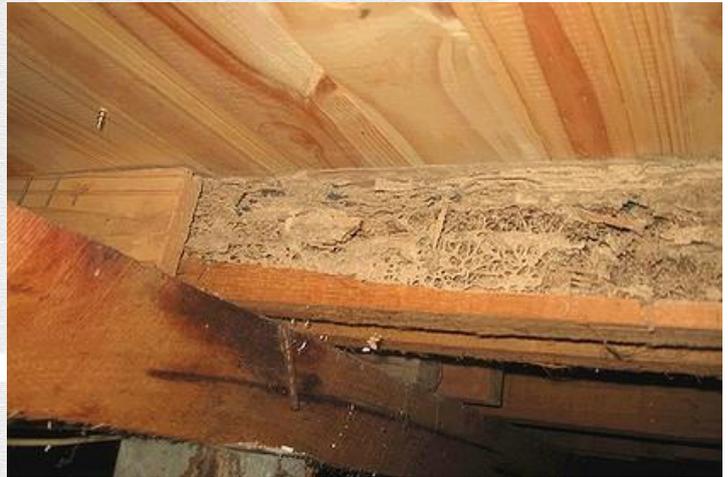
- Subfloor framing timbers in the north/western corner of the property

- Yes
 - Extensive termite damage was visible (Refer to 2.3).

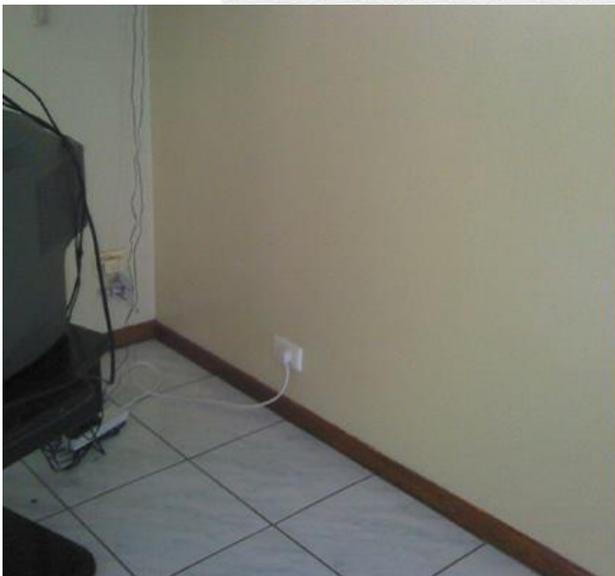
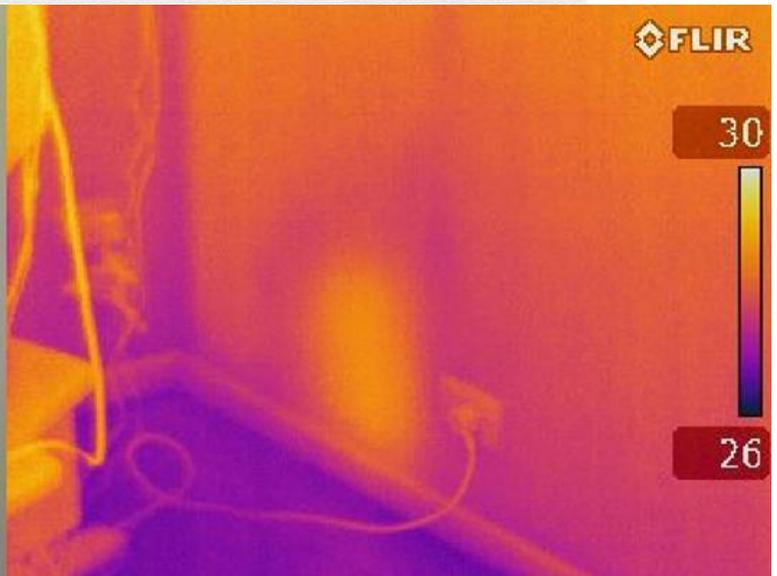
- Wall Lining – Rear north/western rumpus room

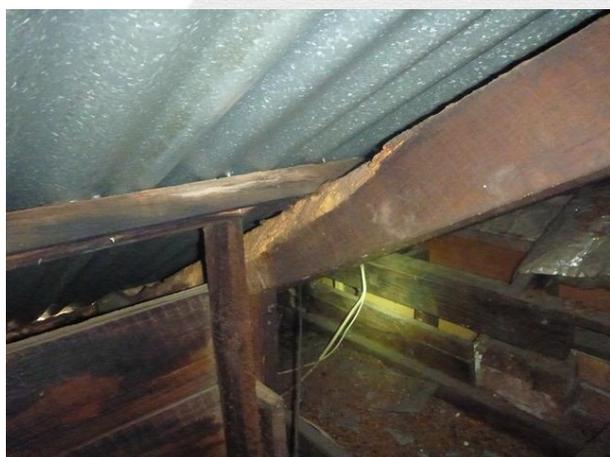
- Yes
 - Species: *Lyctus brunneus* - commonly known as the Powder post Beetle
 - Moderate damage was found in – roof rafter

- No treatment recommended at this stage

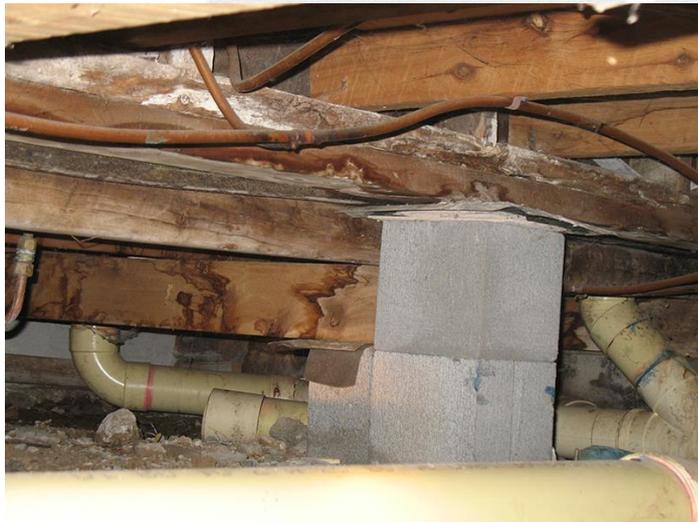
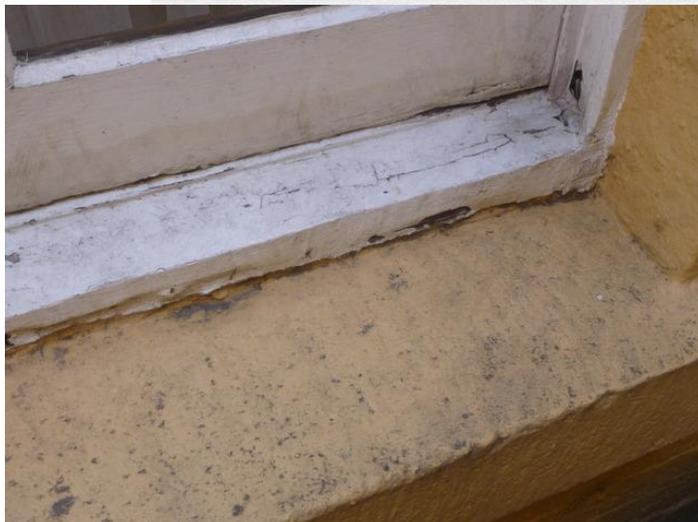
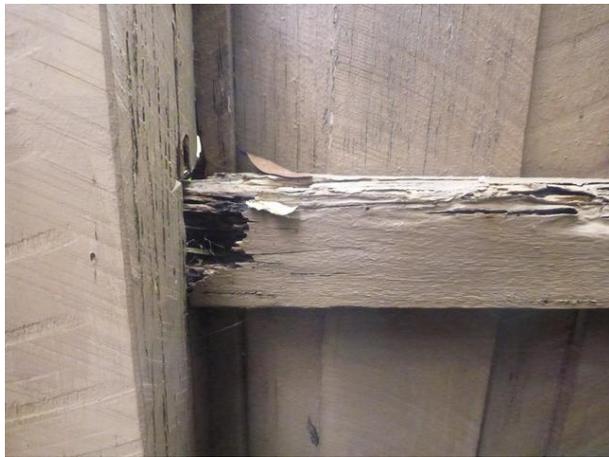
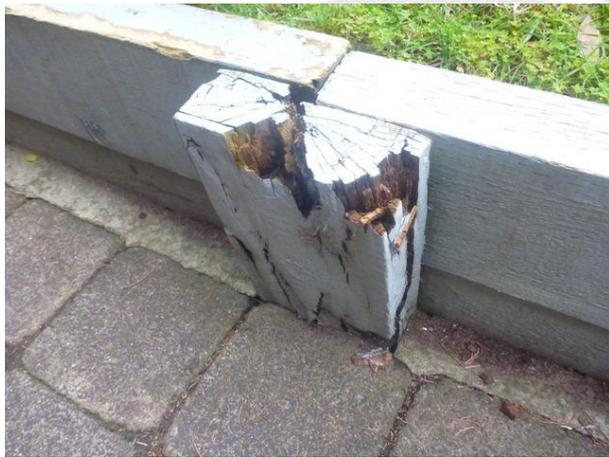
- Yes, found in, but not necessarily limited to
 - Northern windows
 - Subfloor framing
 - Southern fence
 - Timber retaining wall

- The damage is considered to be moderate
- Some delignification was observed on timber battens located in the roof cavity. Delignification is the deterioration of timber brought about by the chemical breakdown and the separation of the cell walls of timber. These timbers need to be replaced by a qualified carpenter.

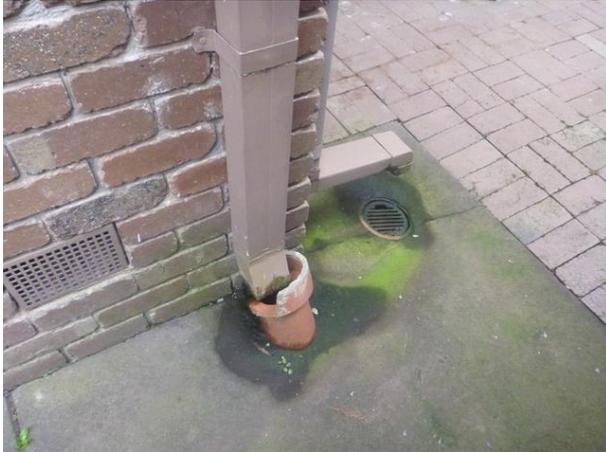
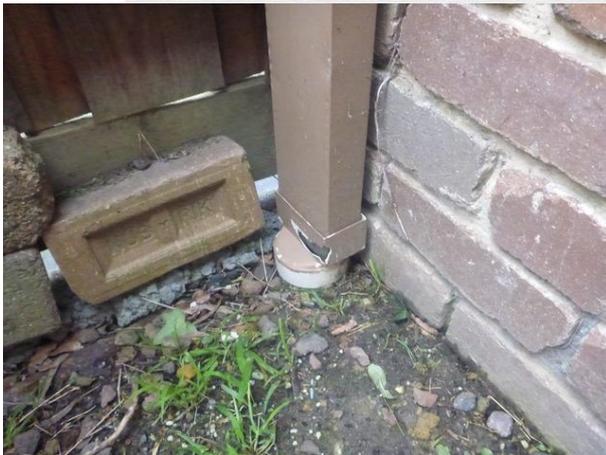
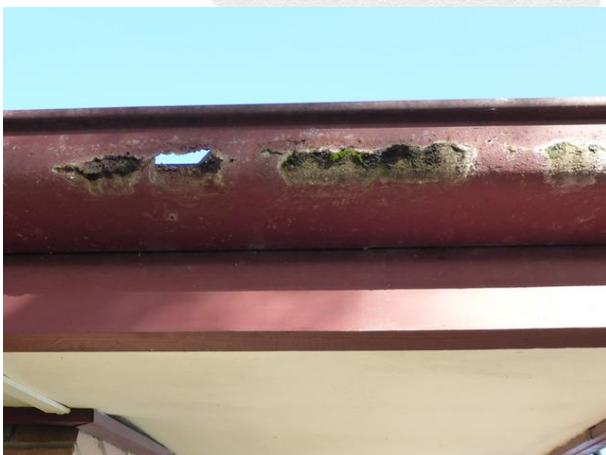
- There are gutters and downpipes that are leaking throughout sections of the site. These leaks need to be rectified by a qualified plumber. This moisture can cause conducive conditions for termites. The degree of risk is moderate to high.

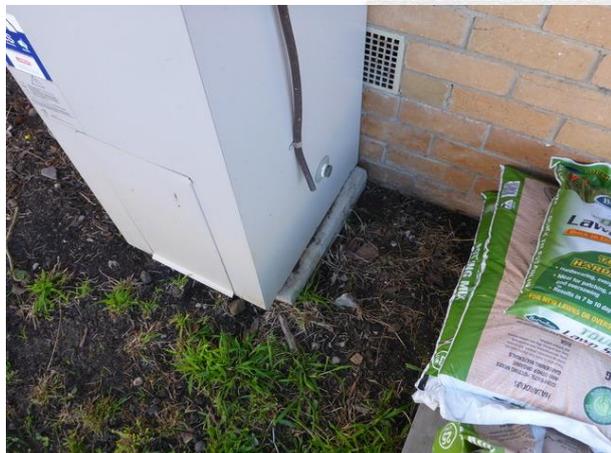
The hotwater service unit overflow needs to be redirected. Moisture is a conducive condition for termites and needs to be removed. The degree of risk is moderate to high.

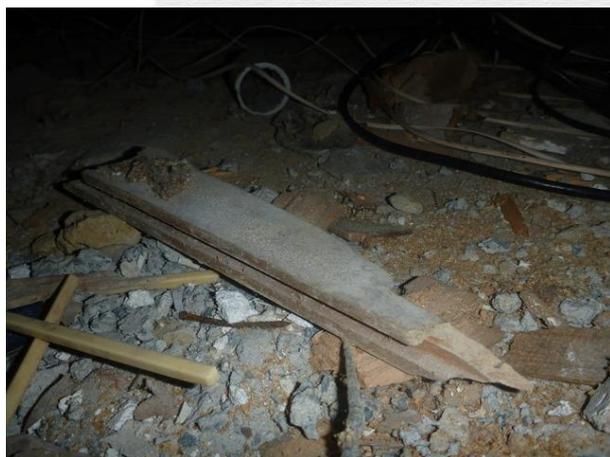
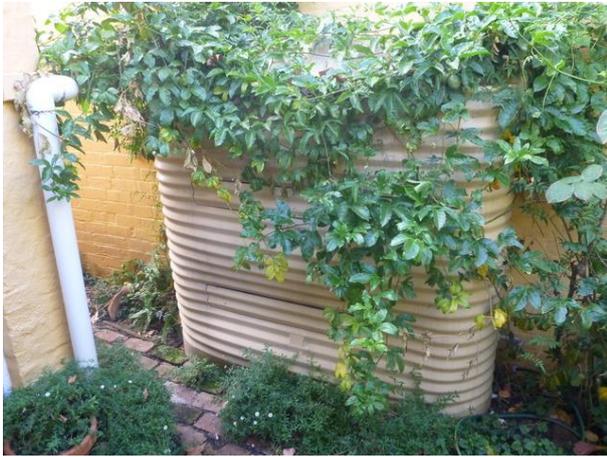
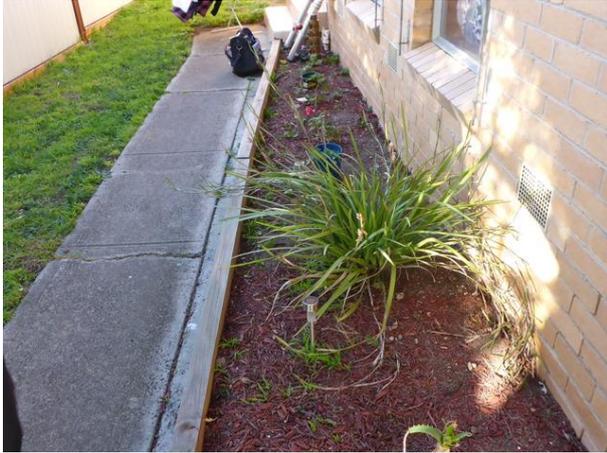
The western section of the roof interior was unable to be inspected, as there wasn't sufficient access and crawl space. The eastern section (kitchen) of the roof interior (roof structure) was unable to be inspected, as it is a skillion design roof (flat roof) there is no roof space. It is strongly recommended that full access be granted of the roof void to enable a thorough inspection to take place as it could be harbouring timber pest activity.

The building was attached to the northern and southern neighbouring properties. Therefore these exterior walls were unable to be inspected. It is strongly recommended that full access be granted to enable a thorough inspection to take place as it could be harbouring timber pest activity and / or damage.

There is heavy vegetation present throughout sections of the boundary timber fence. This need to be removed as it is currently preventing a thorough inspection-taking place. It is strongly recommended that full access be gained as it could be harbouring timber pest activity and/or damage.

The entire edge of the rear concrete slab was not exposed restricting a thorough visual inspection from taking place. The slab edge acts as an inspection zone to stop concealed entry of termites into the building. It is strongly recommended that the slab edge be exposed by 75mm (from the top slab edge to the foundation/dirt) to enable a thorough visual inspection to take place.
